Scaffold Inspection Report

Inspection History

Vitality Stadium

7th September 2017

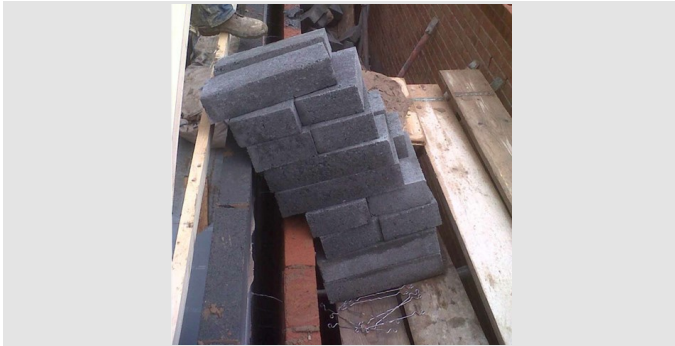
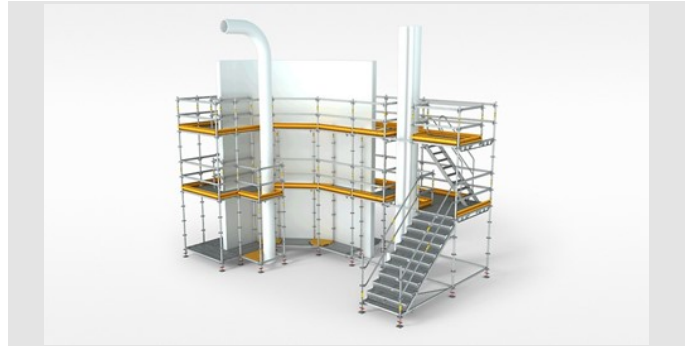
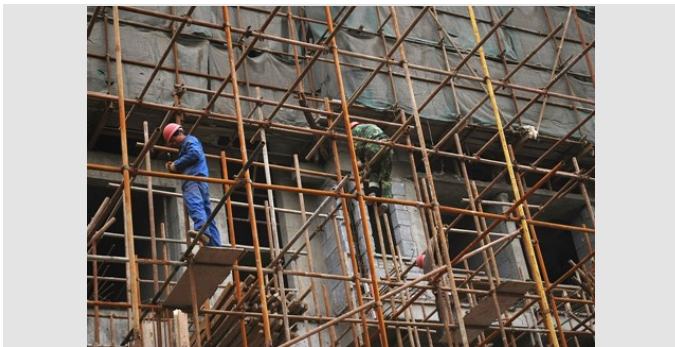
05/09/17 09:44	7	Nm	Passed but some boards were found to be damaged Scaffold Boards Damaged Damaged boards need replacing	Taylor Smith 05/09/17	John Smith
