FIRST COUNTY SCAFFOLDING

SCAFFOLD INSPECTION REPORT

York Post Office

4th January 2018

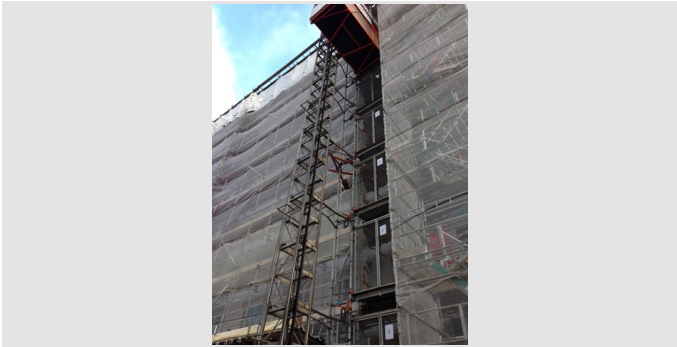
| "Scaffold ground needs to be prepared for the scaffold weight requirements"

<p>00004 - Main retail complex, Access scaffold for remedial repairs</p> <p>Ground uneven and not stable Please see appendix 1</p>	  Jonathan Smith	  04/01/2018
--	---	---	--	--

Appendix 1
Footings:Soft and uneven

Defect	Hazards reported to	Inspectors recommendations
1	Gary Miles	Dismantle the scaffold and prepare the floor for the scaffold requirements

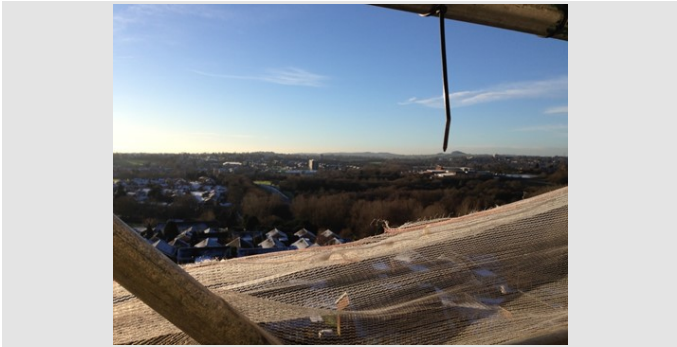
| "Due to strong winds the 2nd lift guard-rail was a bit loose, now tightened"

<p>00002 - Lower ground floor</p> <p>Guard-rail loose on 2nd lift</p> <p>Please see appendix 2</p>	<p>

Appendix 2
Guard-rails and toe-boards:Loose
